# IMPACT OF SOLAR REFLECTANCE OF GLAZING ADJACENT ROOFS

Patrick Roppel<sup>1</sup>, Laurence Matzek<sup>2</sup>, Katie Hay<sup>3</sup>, and Nicolas Proulx-Jones<sup>4</sup>

## ABSTRACT

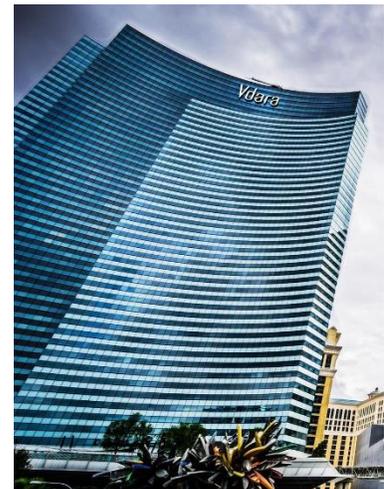
**Figure 1:** The curved glass at the Vdara hotel in Los Vegas on the south elevation focuses solar radiation on the pool area below

Building materials exposed to the outdoor environment are designed to withstand the energy from solar radiation and the expected service lives of materials and systems presume direct exposure to the sun. However, reflection of radiation from adjacent surfaces can amplify the exposure and elevate the surface temperatures beyond what is expected in service and cause damage. There have been high profile examples of this phenomenon that attract attention, such as “death rays” that burn skin and hair at the pool at a Los Vegas resort (NBC News 2010) as seen in Figure 1, melting cars and setting carpets on fire in London UK (NBC News 2013), or a recent fire during construction in Vancouver (CTV News 2021). These examples are extreme because the glazing systems form a concave glass exterior, as seen in Figure 1, that focus solar radiation to a concentrated area and significantly increase temperatures at a concentrated area.

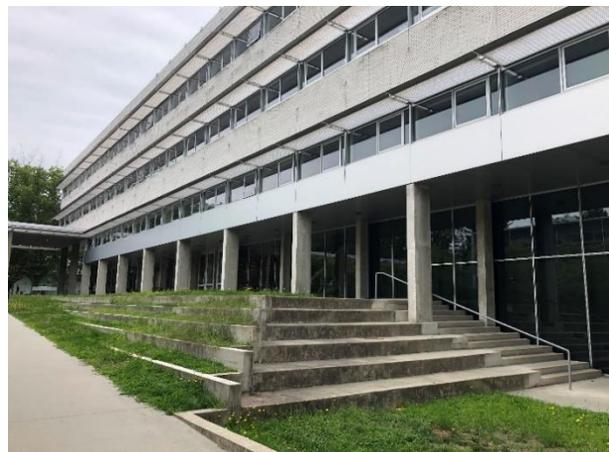
**Figure 2:** AERL Building at UBC with issues at roof areas adjacent to clerestory windows and exposed to direct and reflected solar radiation throughout the day

The Aquatic Ecosystems Research Laboratory (AERL) at the University of British Columbia is a concrete building as seen in Figure 2. The long rectangular building is less than a kilometer from the Georgia straight. There are three roof areas as seen in Figure 3; a narrow upper roof supporting ventilation hoods for the office spaces below, a wide lower-level roof at the northwest side of the building for nearly all the mechanical equipment servicing the building, and a southeast roof on the same lower level that does not have equipment and

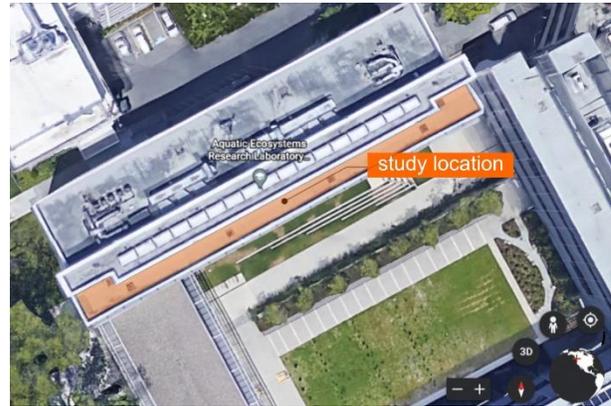
**Figure 3:** The AERL Roof Study Area Orientation as viewed from google maps

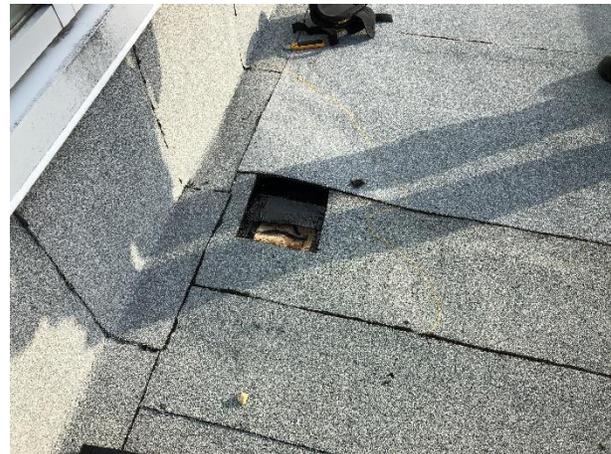
**Figure 4:** Study roof location, looking south-west. Note repair patches along the glazing and not along the parapet that provides shade.

The southeast roof abuts an aluminum framed double-glazed curtain wall (clerestory) along the length of the roof. Blisters appeared adjacent the curtain wall and extended into the roof field by as much as 2.7 m (9') from the glazing. Notably the blisters were not present along the parapet wall that shades the roof as seen in Figure 4. The windows receive full sun exposure, except for some shading from trees on the west at low sun angles.

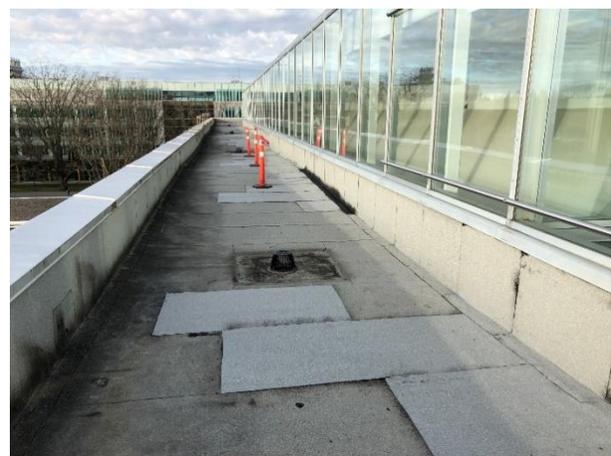
**Figure 5:** Test cut at a blister that reappeared after repairs

The blistering phenomenon was unique to the southeast roof. Cut tests showed debonding of materials inside and around blisters, but there was no discernable liquid moisture between the plies or in the insulation. The blisters reoccurred at the same locations where membrane blisters had been repaired over the previous two years as seen in Figure 5.

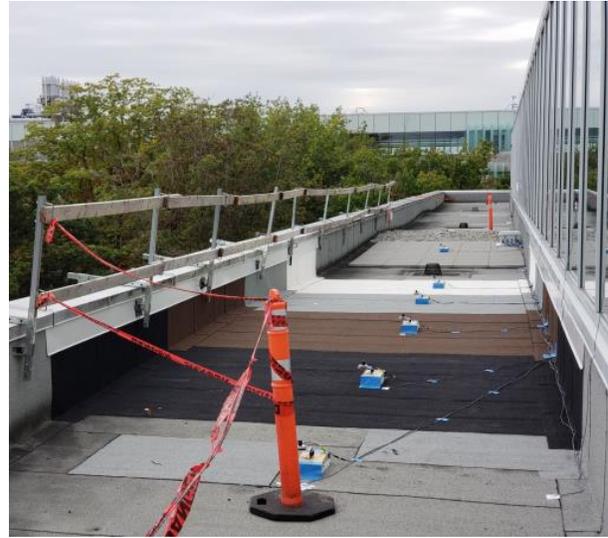
**Figure 6:** Roof sensor layout with various sections of different membrane colours and overburden

To investigate the impact of solar reflectance of membrane temperatures, sensors and monitoring equipment were installed at a section of roof that is adjacent to clerestory windows. The AERL roof study area and sensor locations are shown in Figure 6.

Four roof colours and two overburden types were investigated: black, brown, grey, and white; pavers and gravel respectfully. Surface temperatures and solar radiation were measured and collected between September 2019 – September 2020 for each test area that also included a control area that was unmodified.

Sensors were also installed on the glazed surface, on the vertical membrane flashing beneath the glazing, and on the inside of the parapet to collect temperature data that was not exposed to direct sunlight. All field sensors were placed along the centerline of the roof. Solar radiation sensors were mounted on an isolating wood block affixed to rigid insulation, which inadvertently cast shadows on the surface mounted temperature sensors that will be discussed later in the paper.
