Digiscan 360

Detect leaks, defects, and damages on waterproof membranes

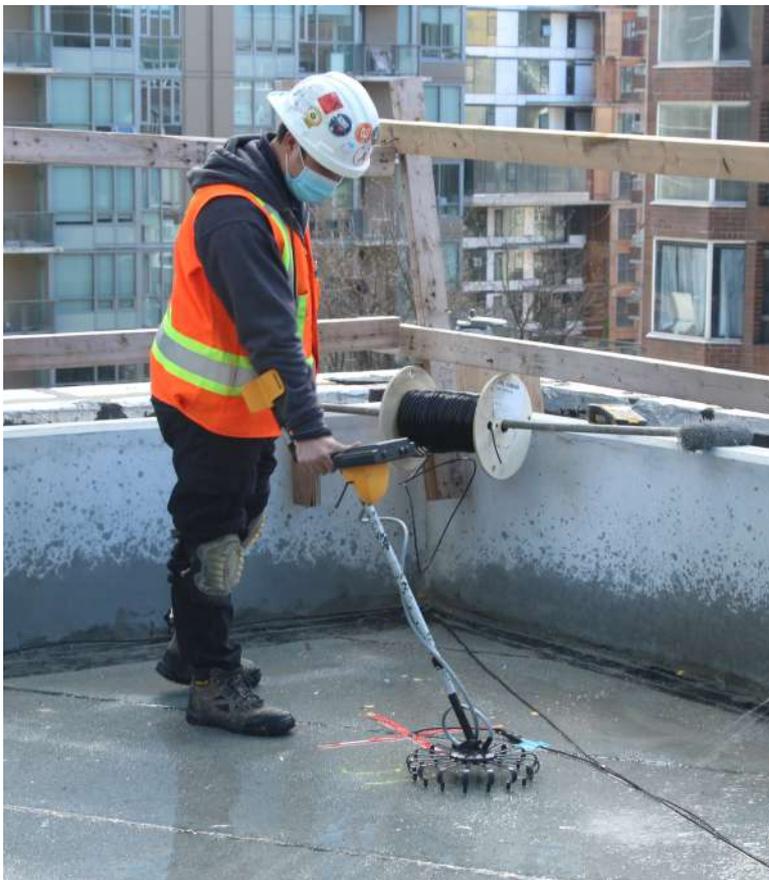
The Digiscan 360 uses a leak detection method called "Electric Field Vector Mapping". The method involves wetting and electrifying the topside of the membrane. The Digiscan 360 identifies where the electric current is escaping, pointing towards leaks and damages in the waterproof membrane.

The Digiscan 360 is easy to use. Proprietary software computes the feedback from the electric field and turns it into a simple display - just follow the arrows!

Digiscan technician's don't need to be standing right on top of a leak to find it, instead the Digiscan 360 points in the direction of leaks - with an effective range of 2-10ft depending on the severity of the leak.

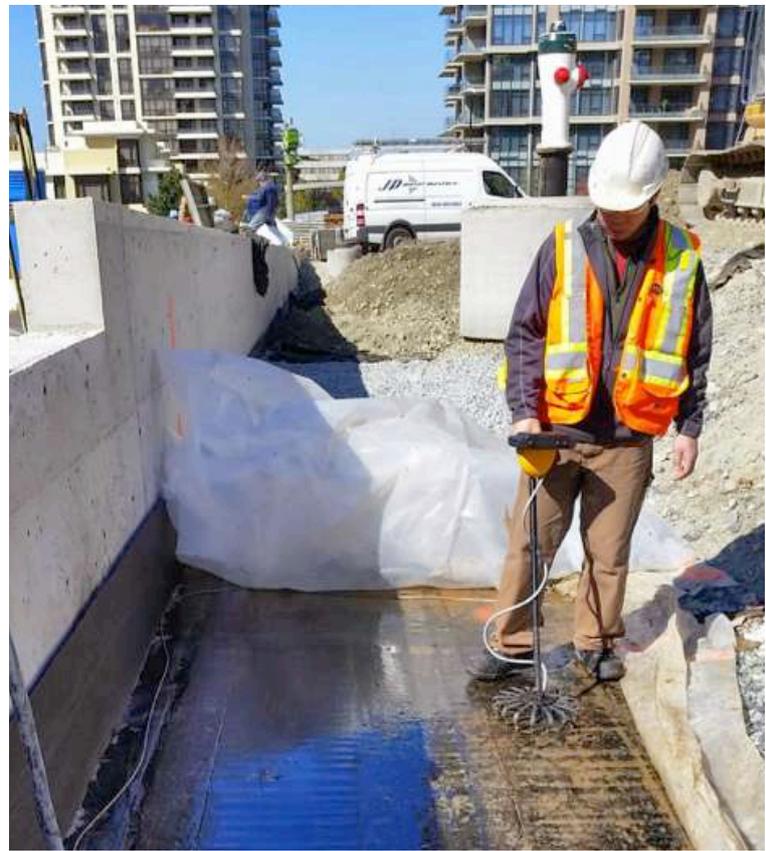
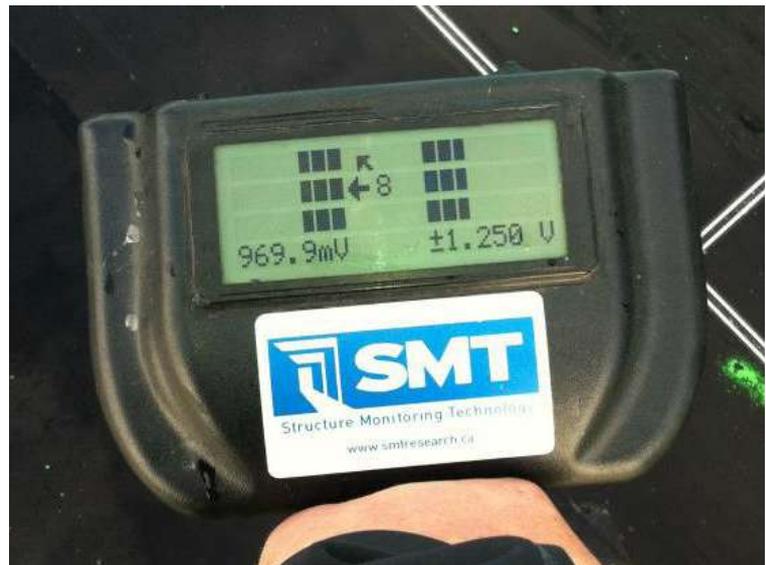
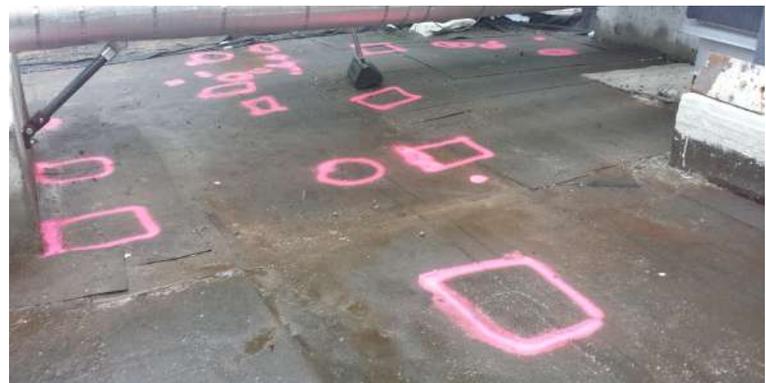
THE PROCESS

- ▶ Connect Power Source.
- ▶ Connect Positive lead to Guard Cable.
- ▶ Connect Negative lead to Building Ground. (rebar, drain, metal object in contact with building or building itself)

- ▶ Place cable around area to test.
- ▶ Typical area is 5x5m to 10x10m.
- ▶ Make sure there are no grounding points inside the cable area (drains, metal pipes, etc)

- ▶ Gently spray the area inside the cable, wet thoroughly and evenly.

Use the DigiScan 360 to locate breach:

- ▶ Press the Digiscan 360 head to the membrane surface every foot inside the cable area.
- ▶ When bar graph increases to a single bar, follow arrows to breach.
- ▶ Voltages < 150mV suggest there are no holes.
- ▶ Upon identifying a leak/hole, the bars in the magnitude meter will increase.
- ▶ Circle the breach area, following arrows to narrow down the area until the breach is found and marked for repair.
- ▶ Consult User Guide for tips and advanced techniques.
